UNDERWATER FACILITIES

INSPECTIONS

ASSESSMENTS

**MARGINAL WHARF
TRIDENT REFIT FACILITY
BANGOR
BREMERTON, WASHINGTON**

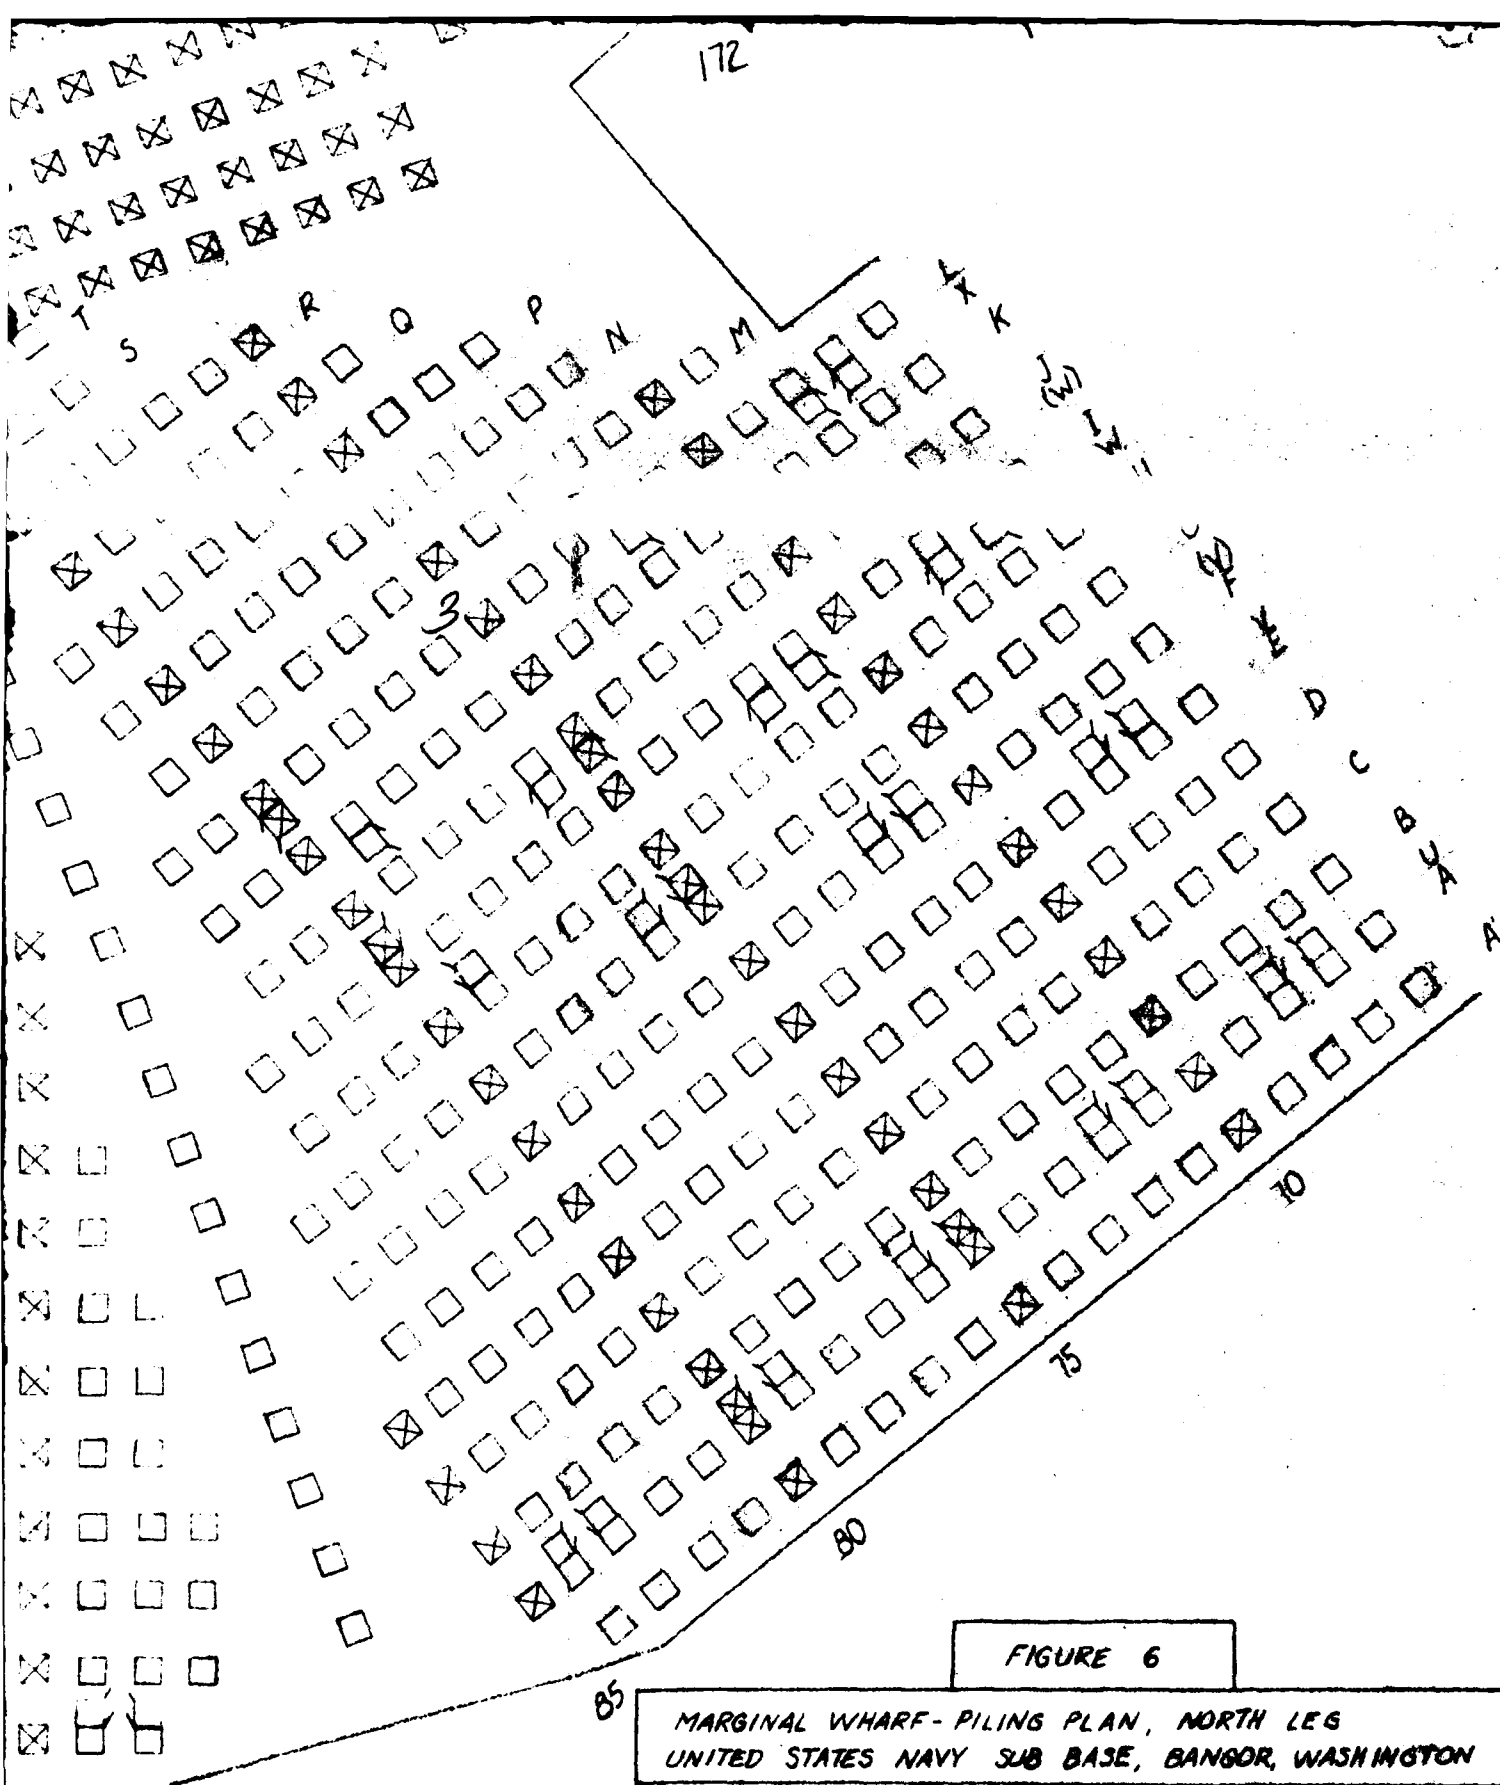
FIGURE 6

The inspection of Marginal Wharf included the portion of supporting piles between the highest high sea level and the underside of the pier deck. Due to the tidal range at the facility, this portion of the piles is only accessible during the high tide cycle (see photograph 17). Damage in this area included cracked piles, fractured piles, and completely severed piles. The inspection team found two piles on the railroad trestle which had cracks radiating from the pipe in the pile in a downward direction, which appears caused by a minor failure of the pile. (See photographs 18 and 20.) Additional piles were found to have cracks at or near the junction of the pile and the pile cap. (See photographs 19 and 21.) Some piles had repairs made of the crack, with the placement of concrete on the pile in these locations. Inspection findings are noted on Figures 6 and 7.

A total of eight batter piles were found to have splices near the junction of the pile and the pile cap (See Figures 6 and 7 for listing). These splices were not completely aligned with the axes of the pile. This condition is considered to be the result of the precast concrete pile driven deeper than originally planned and the splice used to make up the additional required length. (See photograph 22).

Several piles were found to have severe structural damage between the mean sea level and the underside of the pier (See Figures 6 and 7 for listing). For the most part, these were piles that had severe fractures or were completely severed from the pile cap. One such pile was pile 138-A, which was broken from the pile cap at the junction of the pile and pile cap. (See photographs 23 and 24.)

MARGINAL WHARF- PILING PLAN, NORTH LEG
UNITED STATES NAVY SUB BASE, BANGOR, WASHINGTON
